ASCOS trip report

Summer 2008

Paul E. Johnston

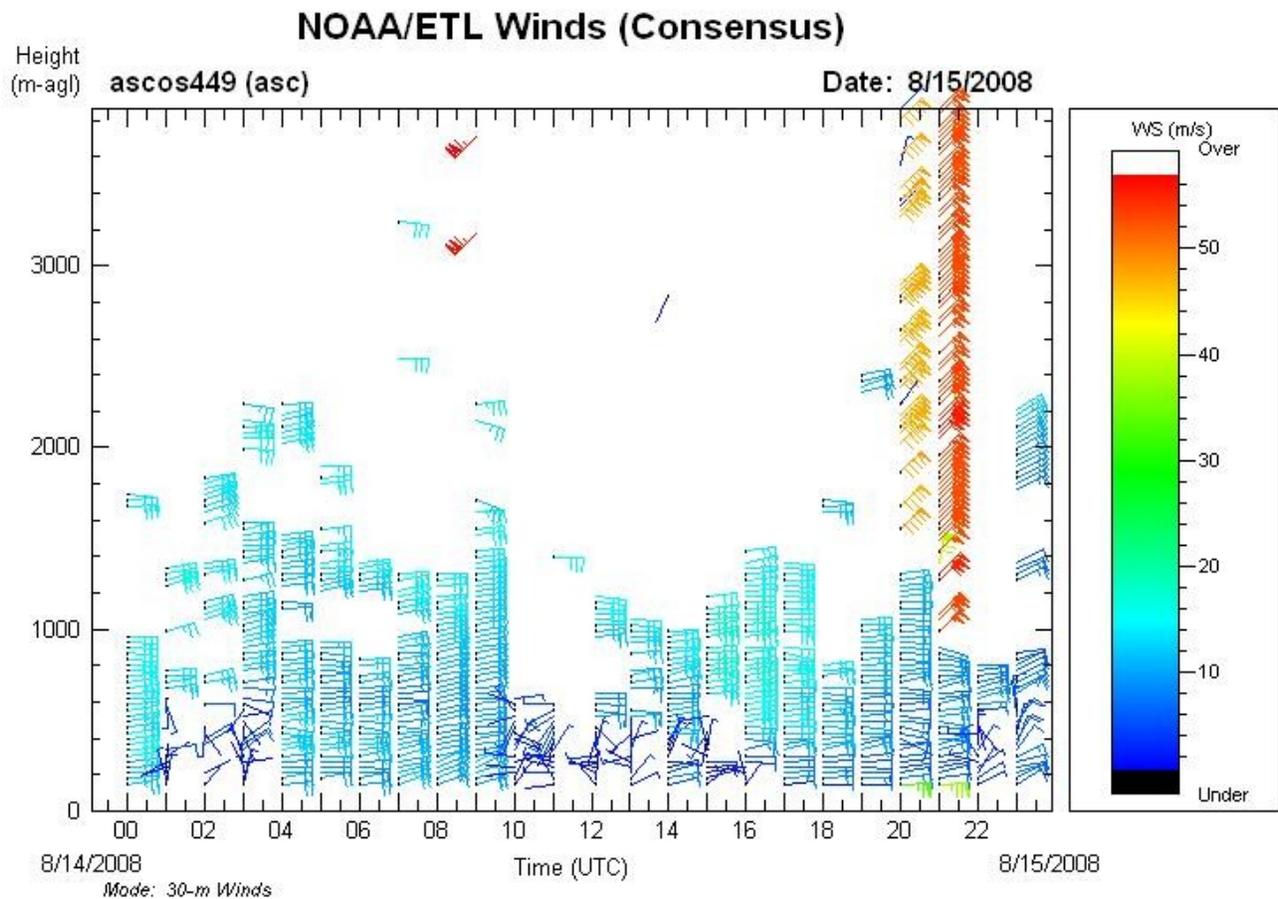
Figure 3. Preliminary first results from the 449 Wind Profiler on the Oden. Data is from a 60 m pulse that has been sampled every 30 m.

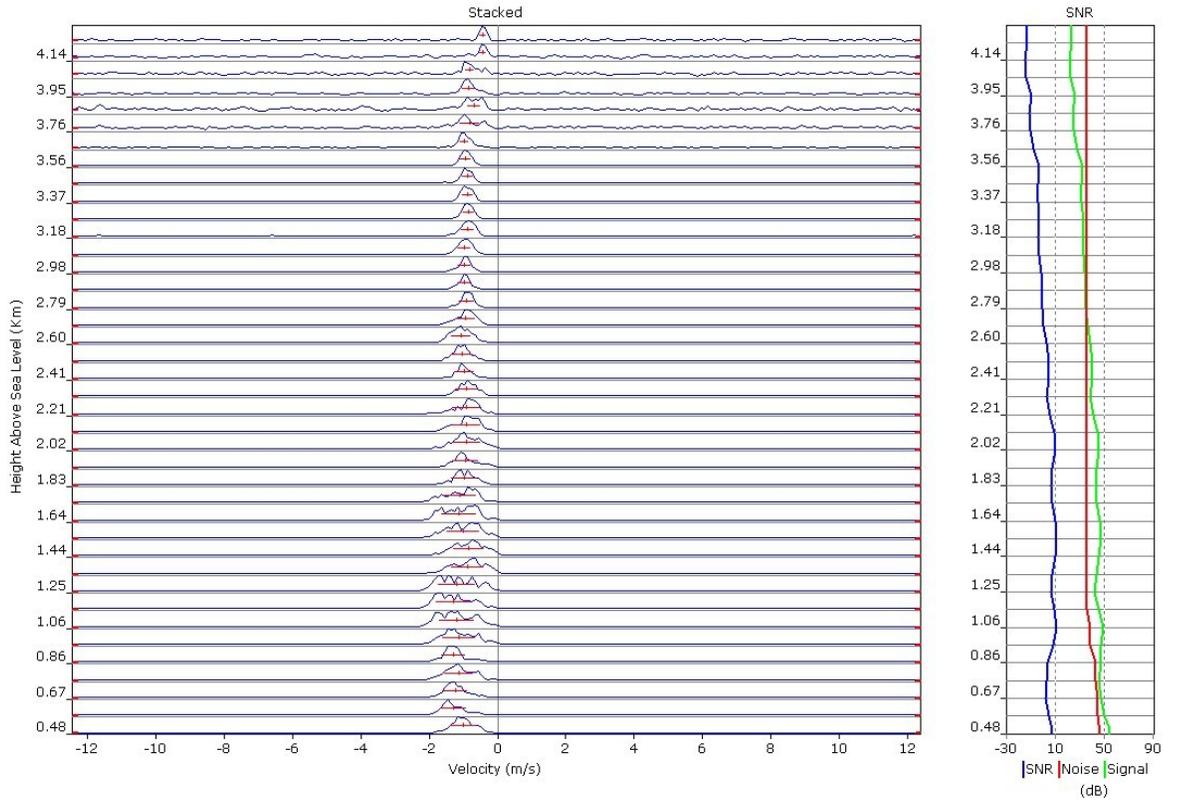
Figure 11.

ASCOS449
 Julian: 236
 Date: Aug 23, 2008
 Local: 03:24:07
 UTC: 03:24:07
 Mode: WB / 4
 Direction: South
 Azimuth: 180.00 deg
 Elevation: 74.69 deg
 Longitude: -2.50
 Latitude: 87.20
 Altitude: 10 m
 Receiver: 1
 NHTS: 80
 NPTS: 256
 Wind Points: 1 - 256
 Pulse Width: 1417 ns
 Pulse Coding: 8
 IPP: 134000 ns
 NCI: 100
 NSpec: 16
 Flip: 0
 Gate Spacing: 667 ns
 Delay: 6750 ns
 Spectral Average: ICRA
 Clutter Removal: 2000 m
 Window: Hann
 DC Filter: On
 iOverlap: On
 Frequency: 449.000 MHz
 Pre-Blank: 3000 ns
 Pre-TR: 1500 ns
 Post-Blank: 1500 ns
